FIRE ENDURANCE TESTS OF PLYWOOD ON STEEL JOIST FLOOR ASSEMBLIES, WITH AND WITHOUT CEILING

(Test Numbers 492, 497)

H. Shoub, B. C. Son

March 1973

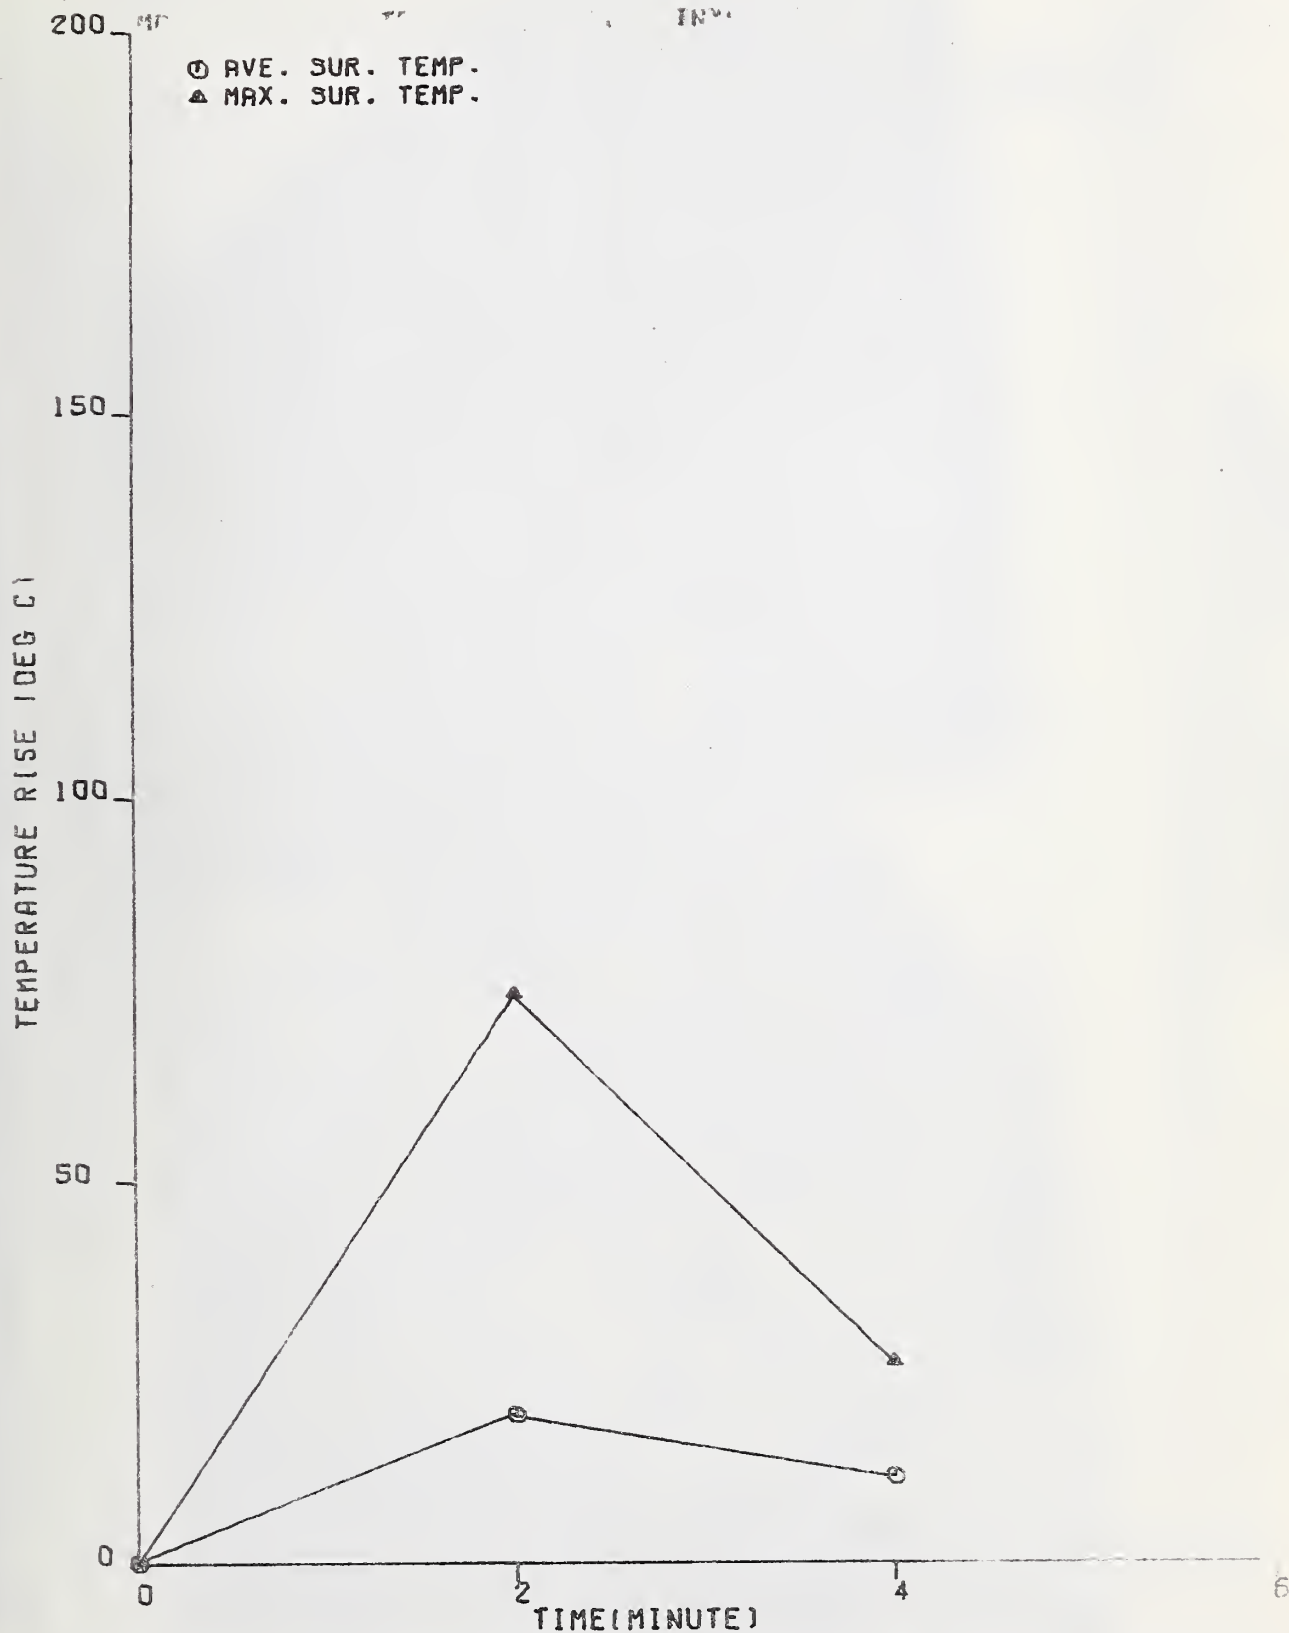
Figure 10 - FLOOR OVER FOUNDATION SPACE - MAXIMUM AND AVERAGE TEMPERATURE RISE OVER VINYL ON THE UNEXPOSED SURFACE

Maximum and average temperature rises on the unexposed surface (over vinyl floor covering, figure 10; over carpeting, figure 11) were low, and did not approach the limits defining failure by transmission of heat. The recorded data indicated little or no effect of the flame penetration, probably because this occurred at one end of the floor, somewhat away from the thermocouples.

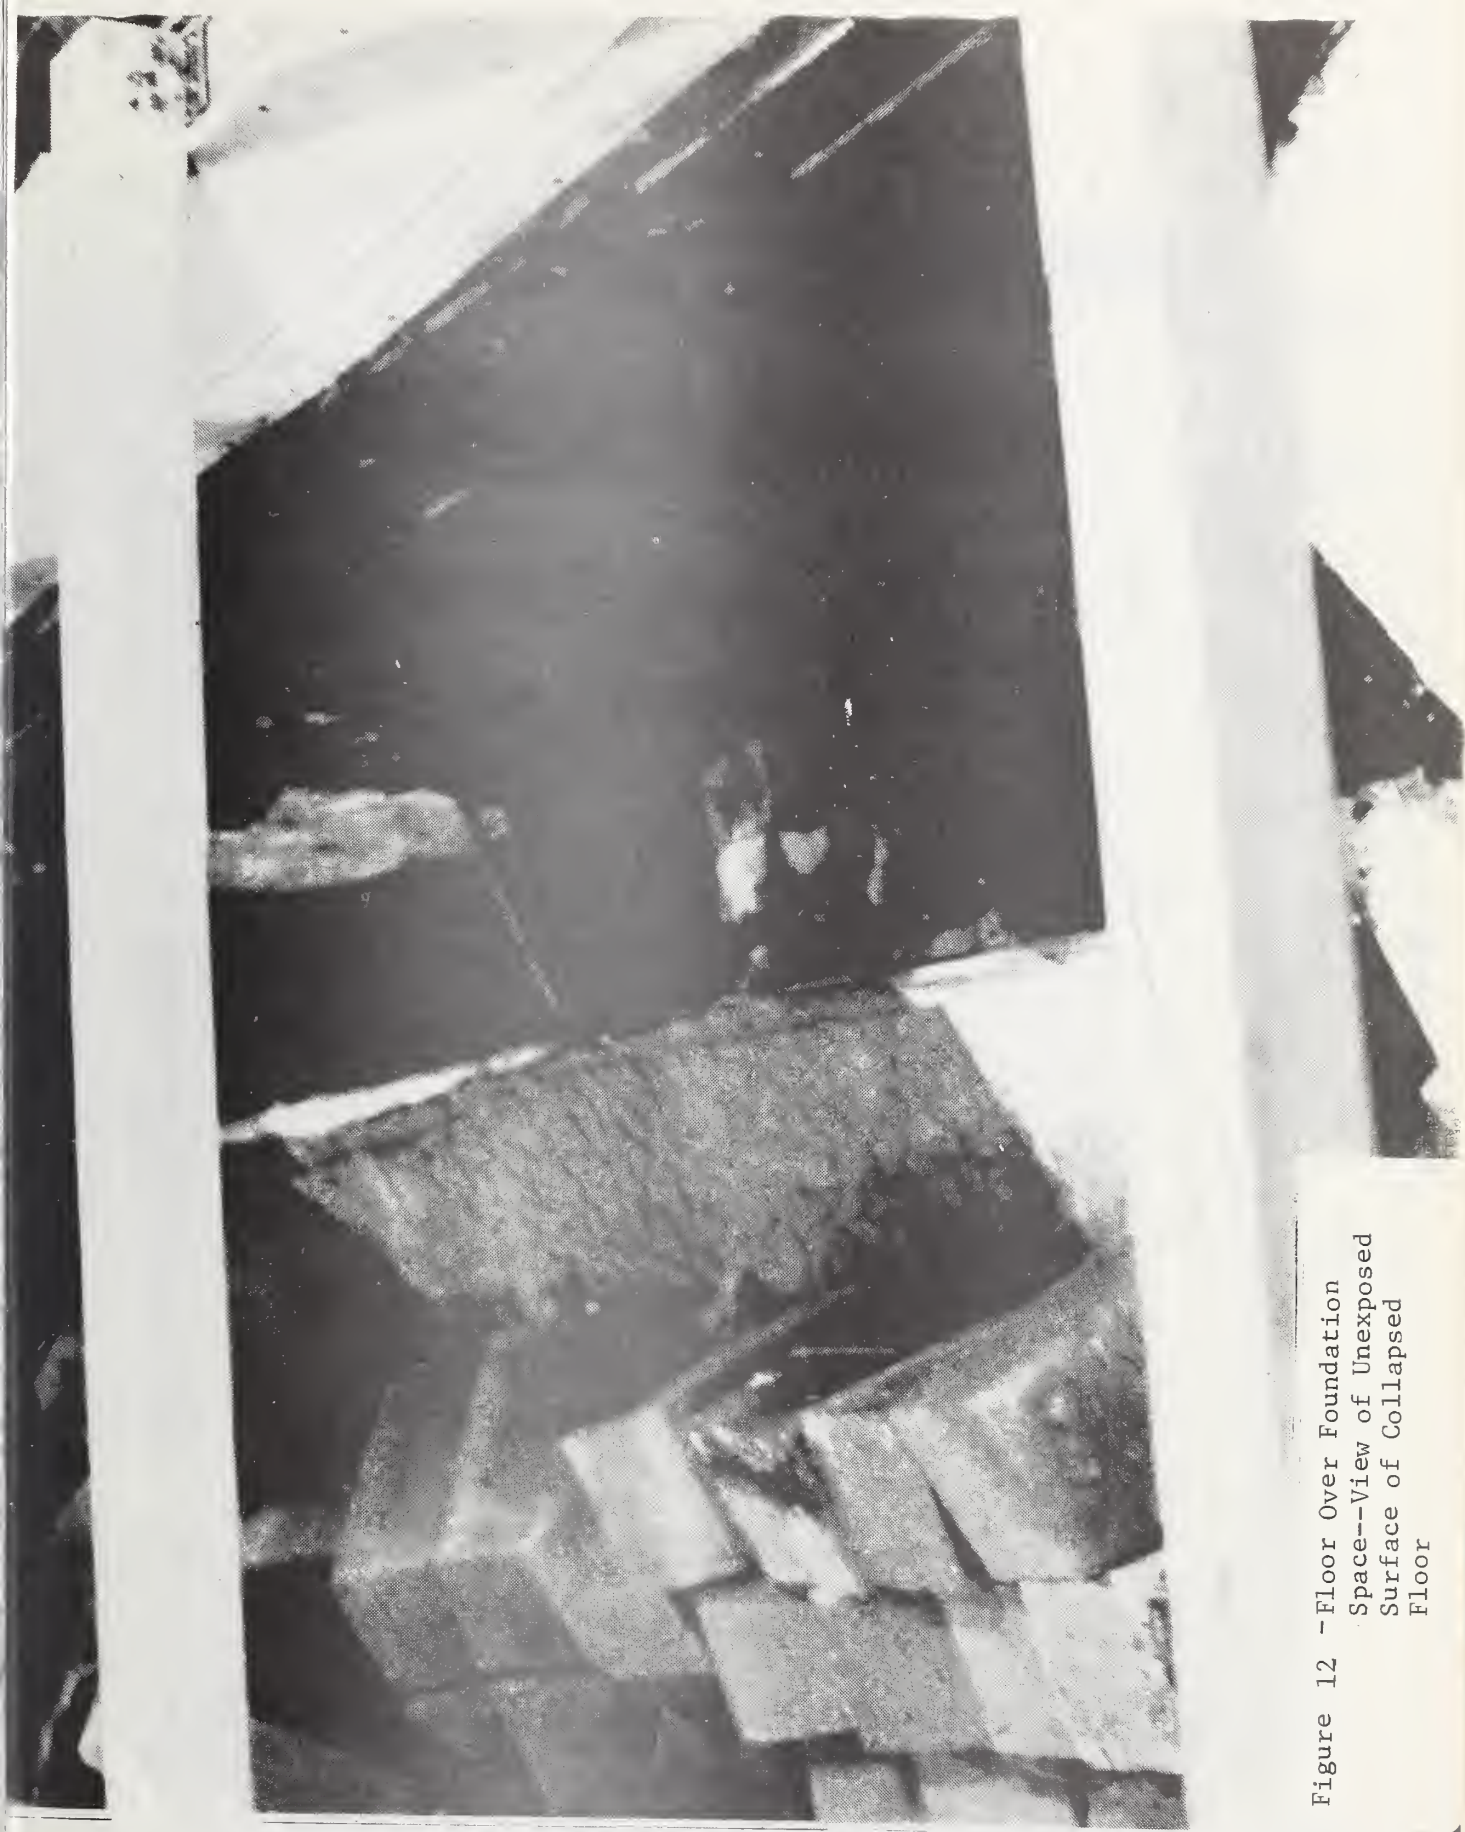
Figure 12 -Floor Over Foundation
Space--View of Unexposed
Surface of Collapsed
Floor

Failure of the floor structure over the foundation or crawl space was observed at 3 min. 15 sec. after start of the test when flames penetrated the unexposed surface. At 3 min. 45 sec. the entire floor collapsed into the furnace under the superimposed load of concrete block, probably as a result of failure of the welded joints at the perimeter framing.

A view of the top or unexposed surface of the collapsed floor is presented in figure 12.

For the unprotected floor assembly over a foundation space, failure occurred at less than 5 min. with the indicated furnace temperature considerably less than 1000°F. This can be explained by a lag in the furnace temperature readings which are based on thermocouples in heavy iron pipes. The actual furnace temperature was considerably higher during the early stage of the test. Of greater significance than the loss in yield strength of the structural elements at elevated temperature was their rapid expansion which caused the welded attachment to the perimeter framing to break within a few minutes after start of the test.

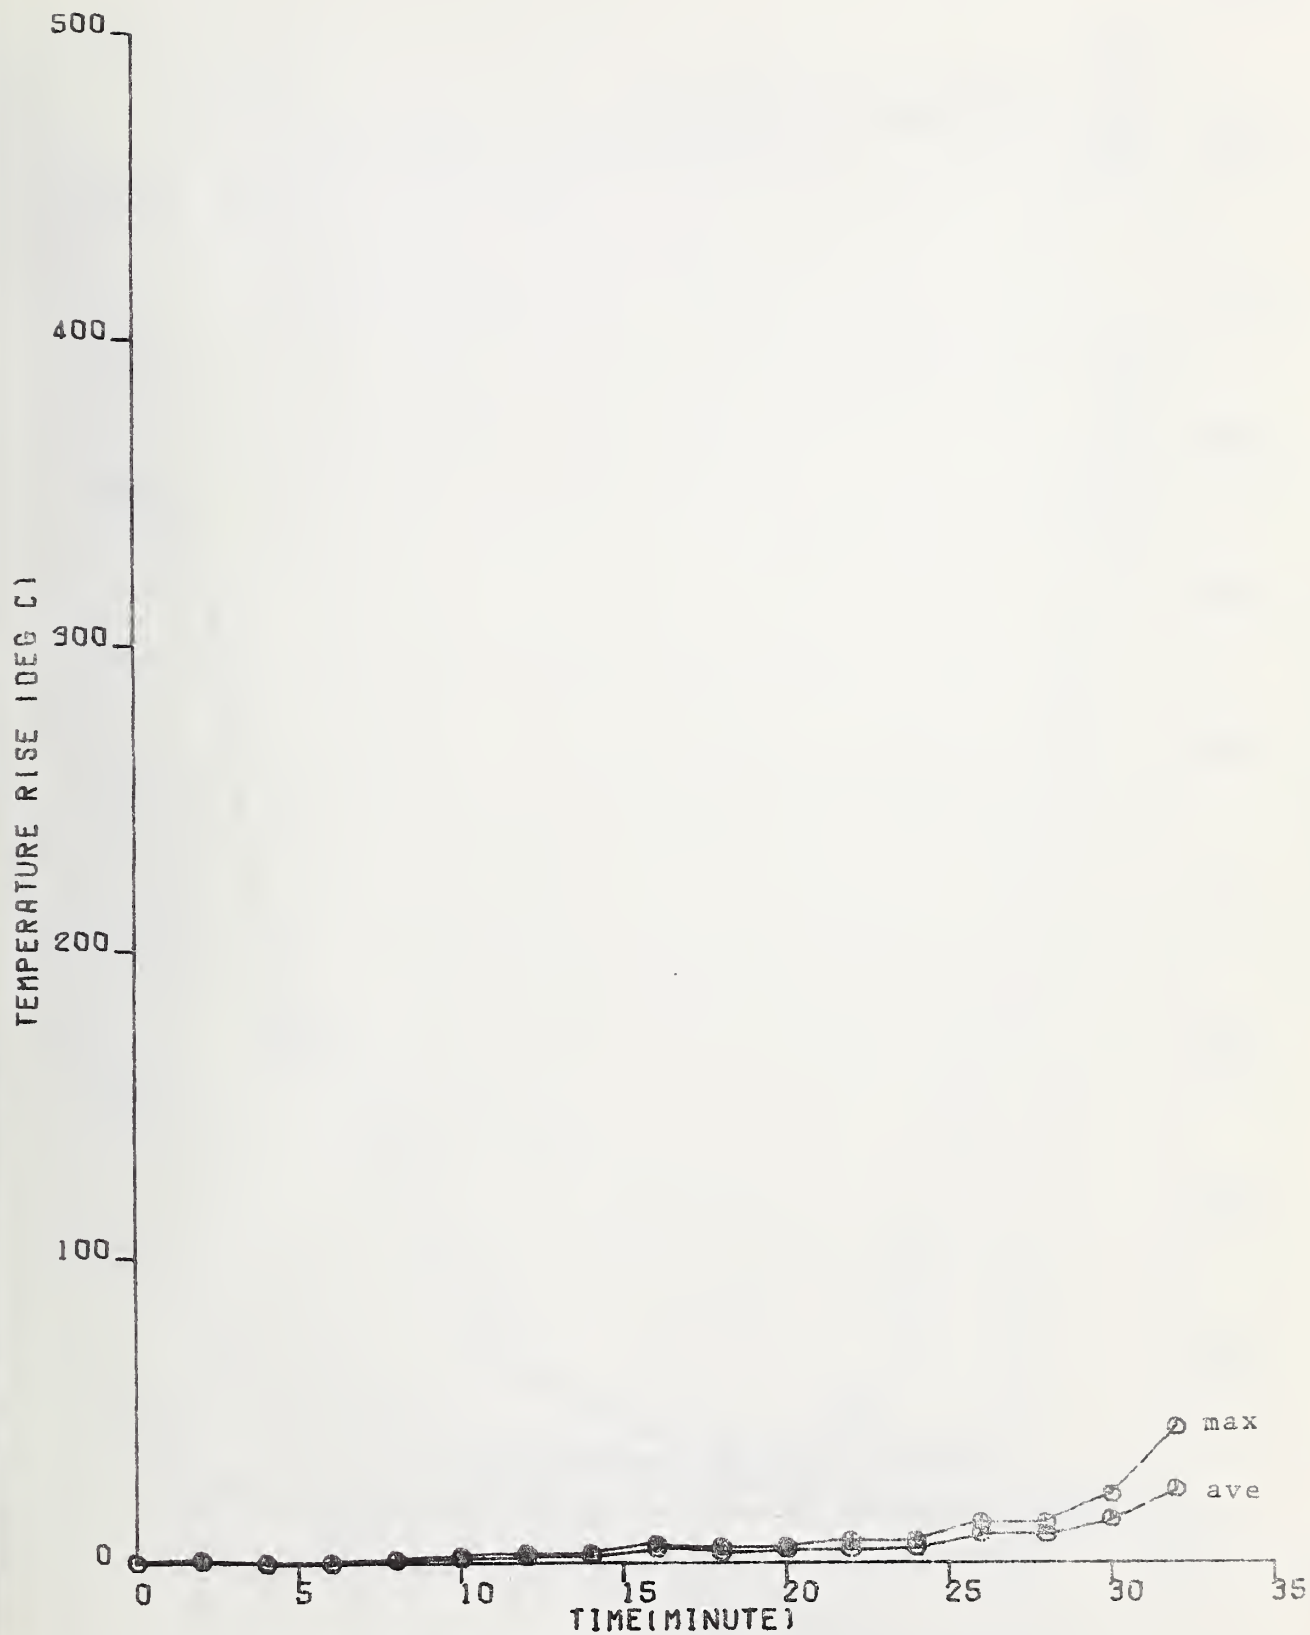
Figure 14 - FLOOR-CEILING ASSEMBLY
Maximum and Average Temperature
Rise on Unexposed Surface (Carpet)

Average and maximum temperature rises on the unexposed surface were not significant, with the maximum rise not exceeding 50 degrees C on the carpet at the end of the test, as can be seen in figure 14. Surface temperature rises in the area covered with vinyl flooring did not approach those over the carpet. As before, the flame through occurred in an area away from the thermocouple locations.

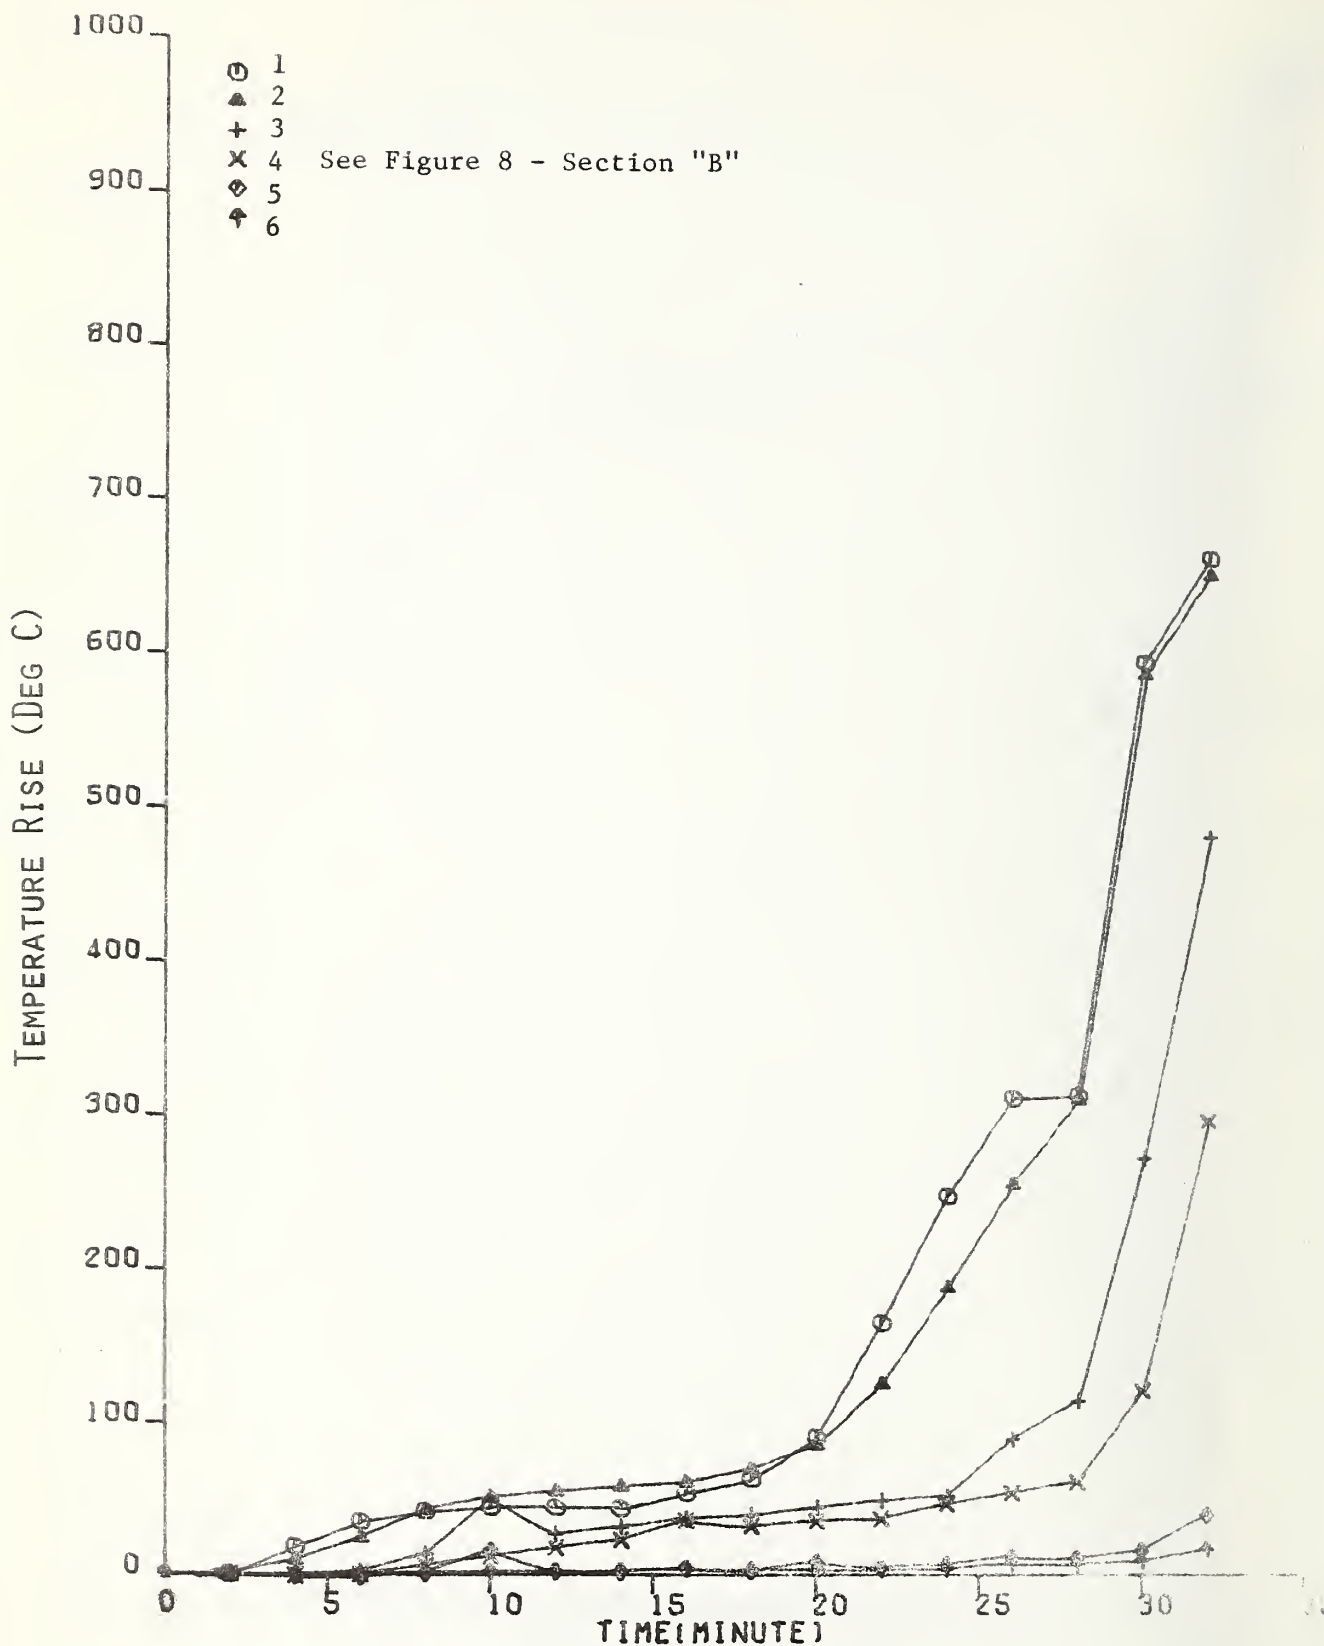
Figure 15 - FLOOR-CEILING ASSEMBLY
Average Temperature Rise
on Steel Joists

Temperature rises on the steel joists and adjacent structure are illustrated in figure 15 (average) and figure 16 (maximum). Similar rises in the area of the ceiling duct are shown in figure 17, giving the average temperature changes. Maxima in this location were not significantly higher. Temperature rises through the assembly at locations not at joists were noted to be somewhat lower than those indicated for the thermocouples at sections through the joists.
